An investigation of characteristics of Materials and Techniques used for the repair of Kala Burj, Lahore Fort, Lahore

Najma Kabir^{1*}, Khizar Hayat², Arsala Hashmi¹

1. Department of Architecture, (SAP), University of Management & Technology Lahore Pakistan.
2. Water and Power Development Authority, (WAPDA), Chief Engineer, Central Design Office (WATER) Lahore, Pakistan.

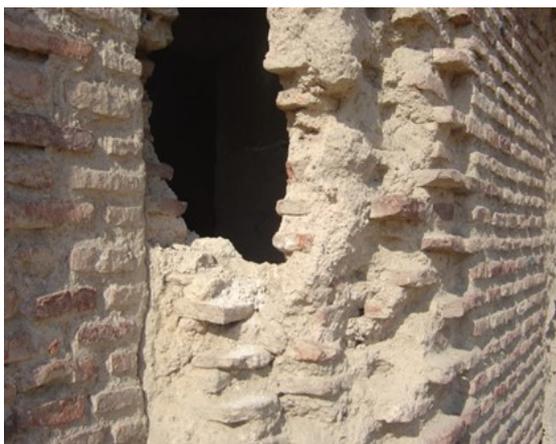
Fig. 5: Area of Kala Burj from where Sample was Collected, 2019 (source Authors)

While taking the mortar sample care was taken that it was original and did not belong to the renovated part of the building [17].

To find out the characteristics of mortar used in Lahore Fort, original sample was gathered from the building called Kala Burj, for the purpose of analysis. Non-invasive methods consisting of visual inspection, photography, qualitative and quantitative analysis were conducted. Photography was used for documentation of the mortar condition. Light binocular or polarized microscopy was applied to determine the distribution of mineral components. Wet chemical analysis was carried out after dissolution in acid for the measurement of

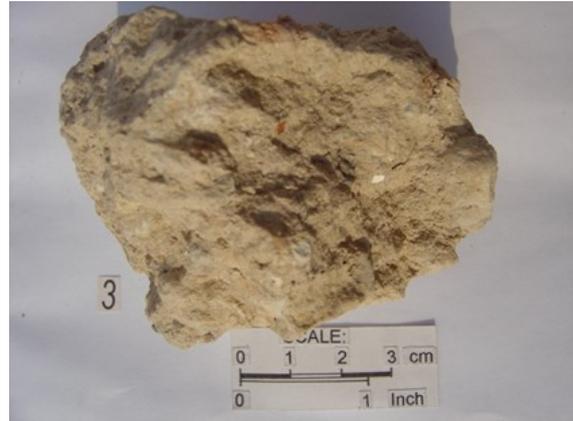
Fig. 6: Kala Burj Mortar Sample No. 3, 2019 (source Authors)

In order to understand and analyze the deterioration patterns and their impact on the tower, it is crucial to fully describe and characterize its building materials. This includes the identification of the mortar's physical and chemical properties in its current state. The original mortar sample was collected from the wall of Kala Burj, as shown in figure 5. To obtain a better observation through naked eyes, the sample was first wiped, then washed with water, and then again rinsed with dilute hydro chloric acid (HCL) as in figure 6.
